Case 242 : Narrative

Case Vehicle (A): 2000 Dodge	Vehicle (B): 1998 Chevrolet
Type: Caravan, minivan	Type: Cavalier, 2-door coupe
Driver: 29-year-old male	Driver: 53-year-old male
CDC: 12-FLEW-3, 10-LDEW-3	CDC: 99-0000-0, 99-0000-00

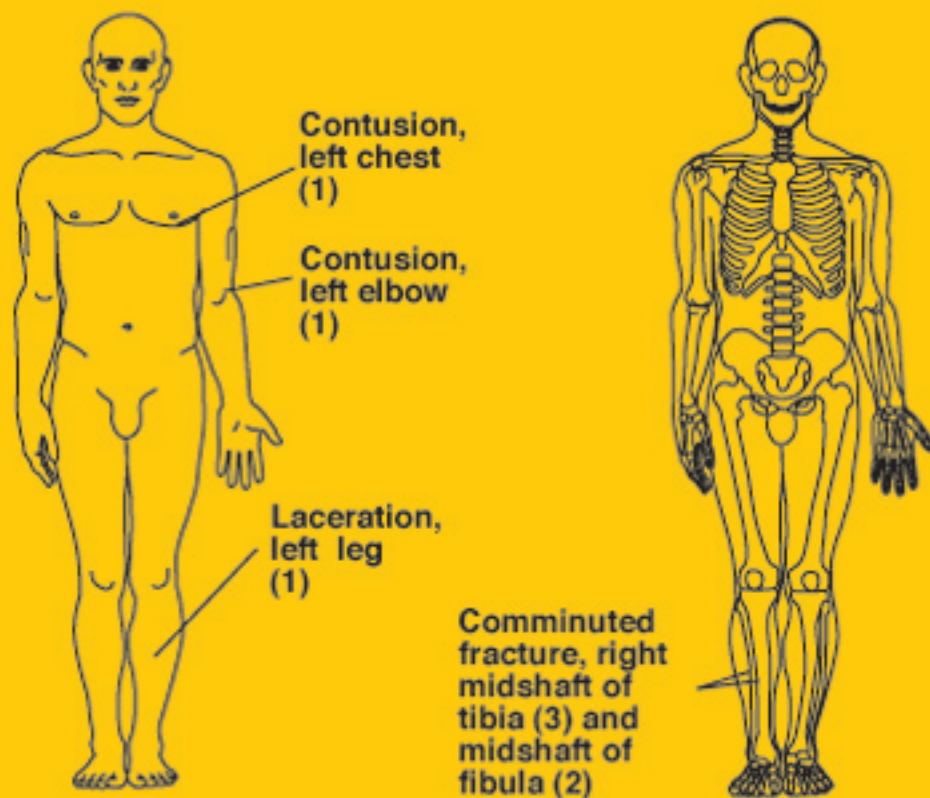
Occupant: Driver	Age: 29 years	Gender: Male		
Restraints: 3-point belt worn; airbag deployed	Stature: 183 cm (6 ft, 0 in)	Mass: 68 kg (150 lb)		
Injury Description	A.I.S.	Injury Source		
—	—	Definite	Probable	Possible
Contusion, left side of chest	1	—	Shoulder belt	—
Contusion, left elbow	1	—	—	Interior door surface
Laceration, left leg	1	—	Flying glass	—
Fracture, comminuted to midshaft of right tibia	3	—	Toepan/ Foot controls	—
Fracture, right midshaft of fibula	2	—	Toepan/ Foot controls	—
Maximum A.I.S. Level	3	—	—	—
Injury Severity Score	10	—	—	—

SEVERITY: MAIS - 3 ISS - 10

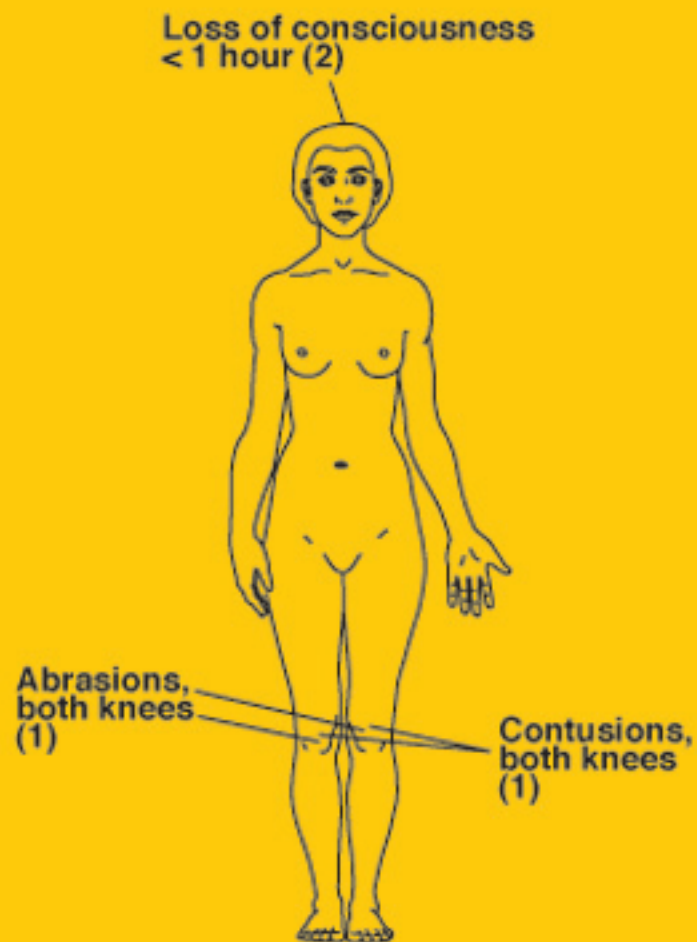
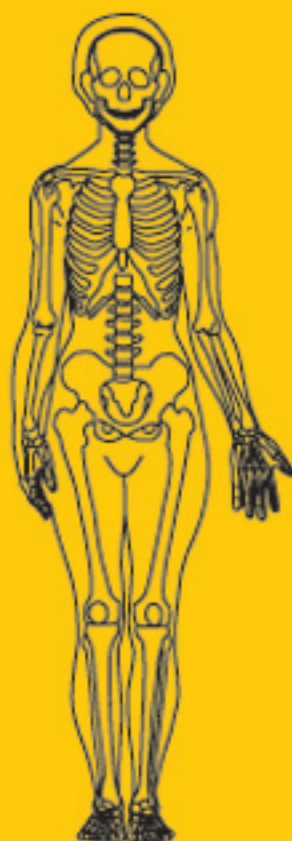
Occupant: Right front	Age: 32 years	Gender: Female		
Restraints: 3-point belt worn; airbag deployed	Stature: 173 cm (5 ft, 8 in)	Mass: 70 kg (155 lb)		
Injury Description	A.I.S.	Injury Source		
—	—	Definite	Probable	Possible
Loss of consciousness < 1 hour	2	—	Impact forces	Airbag
Abrasions, both knees	1	—	Glove-box door	—
Contusions, both knees	1	—	Glove-box door	—
Maximum A.I.S. Level	2	—	—	—
Injury Severity Score	5	—	—	—

SEVERITY: MAIS - 2 : ISS - 5

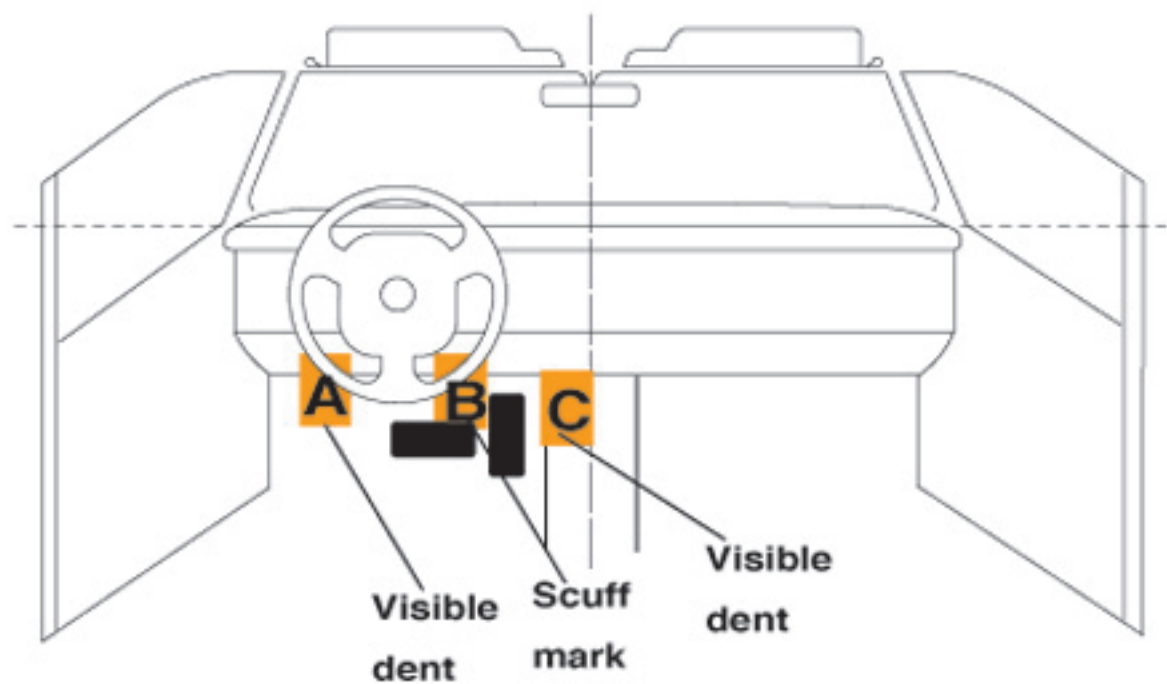
OCCUPANT CONTACT WORKSHEET

Contact	Interior Component Contacted	Occupant No. if Known	Body Region if Known	Supporting Physical Evidence	Confidence Level of Contact Point
A	Knee bolster L of column	1	Knee	Visible dent	1
B	Knee bolster R of column	1	Knee	Scuff mark	1
C	Vertical console	2	Knee	Visible dent	1
D					
E					
F					
G					
H
